# Ask the Lab

## Veneers - Case Study

## Veneer Preparations

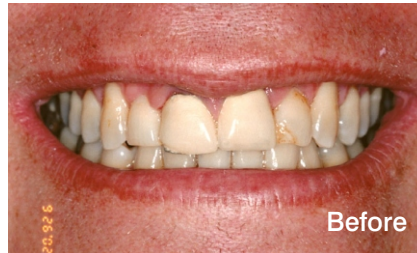
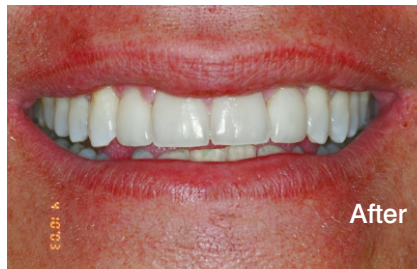
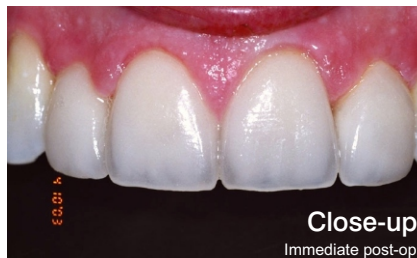
Case prepared and seated by Dr. Kuljic, Beverly, Ma. Shofu Halo Opal All-Ceramic #8 & 9 Jacket Crowns, #7 & 10 Veneers. Fabricated by Killian Dental Ceramics, Inc.

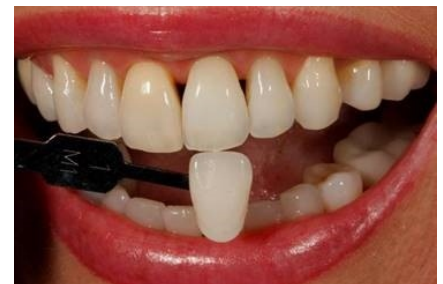
### LABIAL VENEER COLOR AND PREP DEPTH

Provide a shallow chamfer margin at the gingival (A), and proximal margins. The prep depth (B) should be 0.75 - 1.0 mm to provide space to block-out tooth color that is too dark or too light. If the stump shade (prep) matches the desired restoration color, then only 0.5 mm reduction is needed. Provide 1.5 mm incisal reduction (C).

**DEPTH** - Dark stump shades require deeper preparation (0.75-1.0 mm) to enable the ceramist to build a first layer of blocking porcelain (opaqueous dentin) and still have enough room for the surface layers of translucent porcelain. Preps with stump shades that closely match the desired finished restoration shade can be prepped more conservatively (0.5 mm).

**MARGIN** - Shallow chamfer margins enable us to provide the best results. Thin slices or bevels don't hold up well to the mechanical etching (sandblasting) and chemical etching (hydrofluoric acid) processes required to fabricate this type of restoration.
